Manhole Inspection Summary

Manhole # S37U__038MH

Location Address: **rear 1522 covington st.**

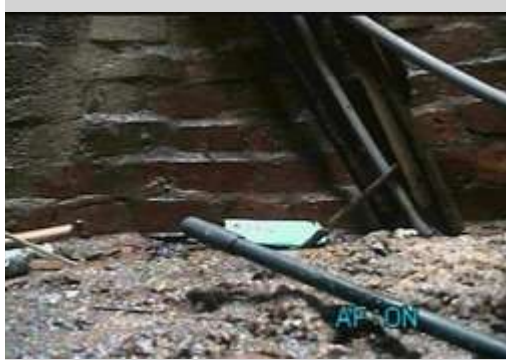
Defect 2

Condition: ☒ Sound ☐ Cracked ☐ Root Intrusion ☐ Deteriorated ☐ Leaks ☐ Debris

debris on bench

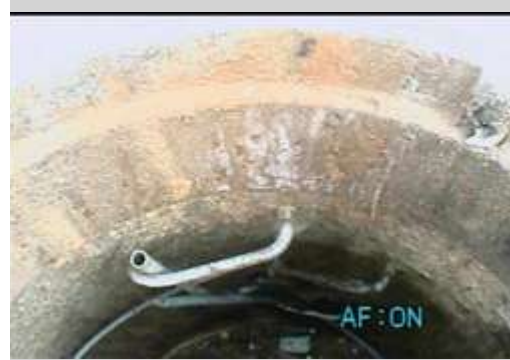
Defect 1

Steps Count: **4** Missing: **0** ☒ **Corroded**

defective steps

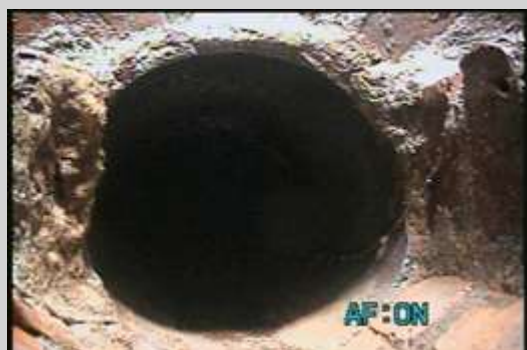
12 O'Clock Outflow

Deposits: ☒ None ☐ Mud ☐ Sludge ☐ **Debris** ☐ Grease

Infiltration: **None** Pipe Seal Cond: **Unknown**

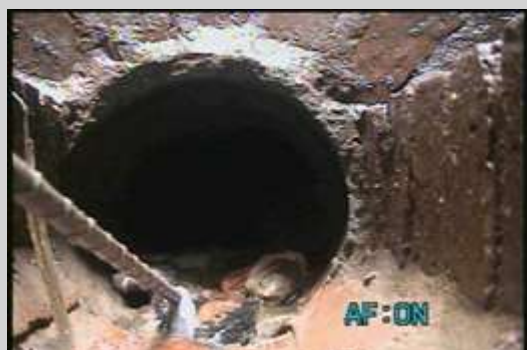
9 O'Clock Inflow

Deposits: ☐ None ☐ Mud ☐ Sludge ☒ **Debris** ☐ Grease

Silt Depth: **2** (in.) Deposits Extent: **Medium**
